Building and Timber Pest Inspection Report

Sample Place, Melbourne, VIC, 0000

Report/Agreement #	2906230215037
Inspection Date:	29 Jun 2023
Inspection Time:	02:15 pm

Pest And Building Inspection

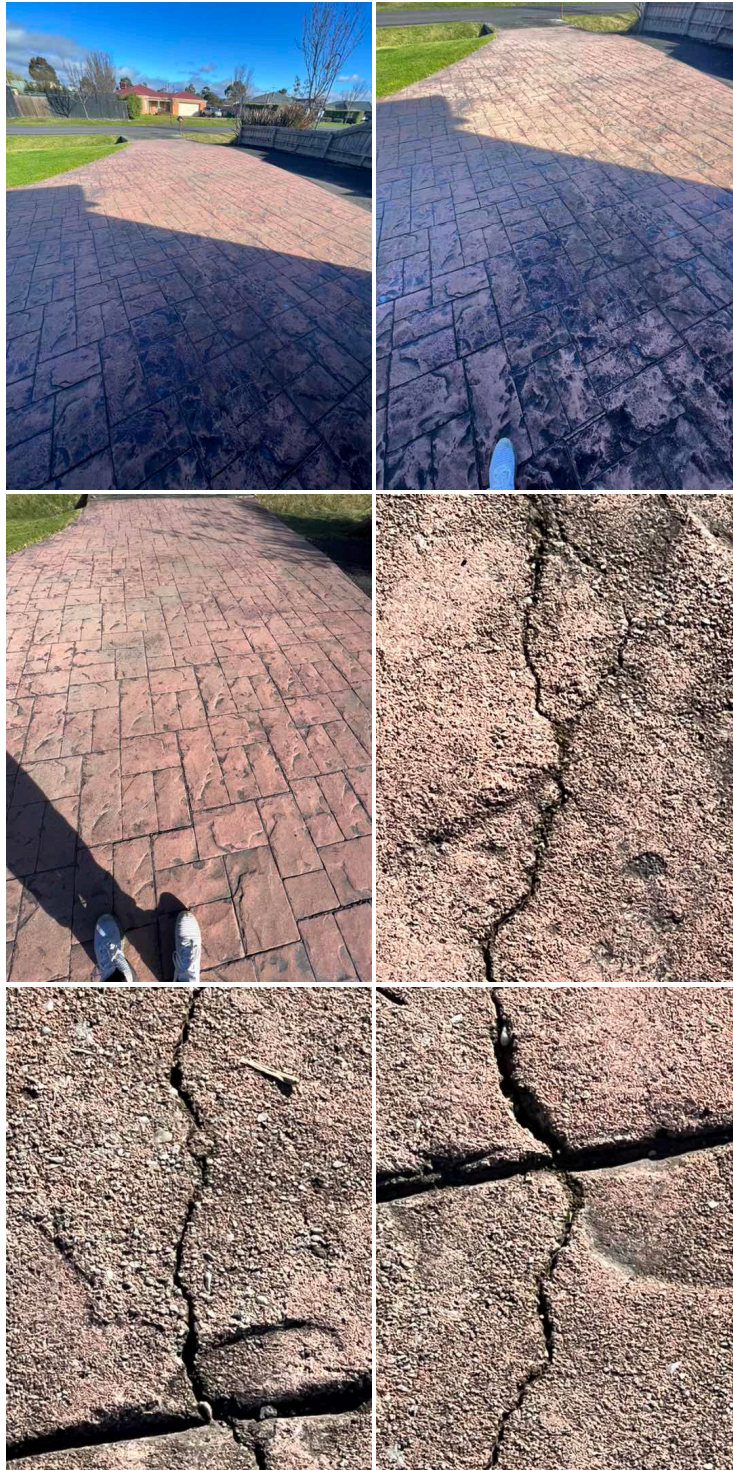
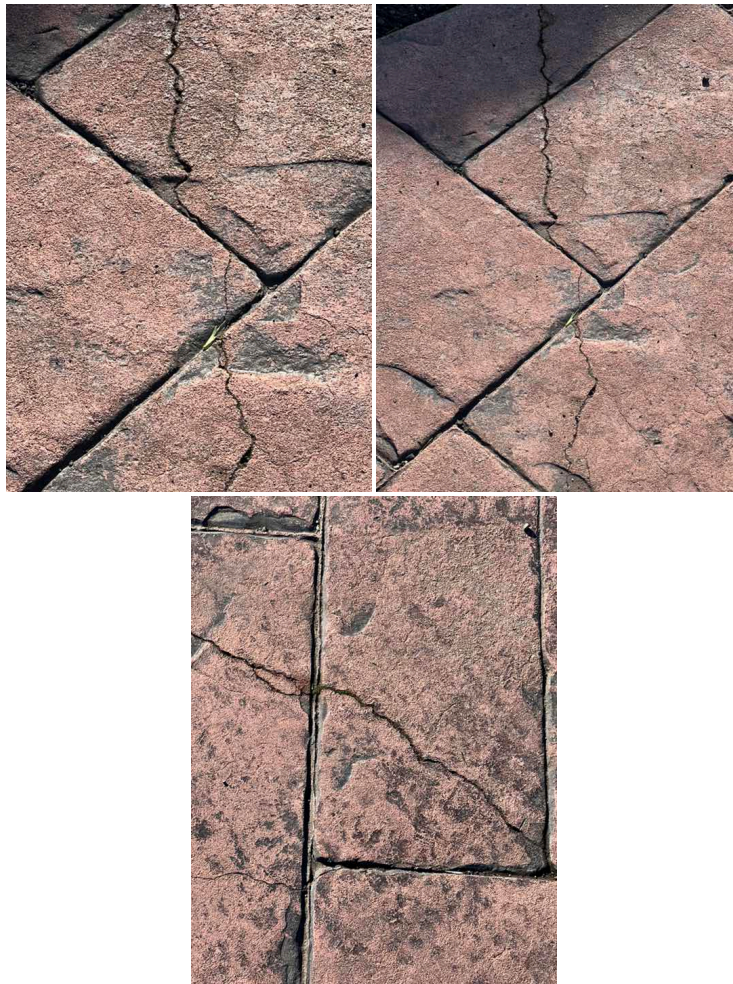
Driveway Condition

Common cracks were observed on the driveway. Whilst these cracks appeared to be typical at the time of inspection, we strongly recommend you monitor these cracks and if worsening occurs contact a concreter for further advice.

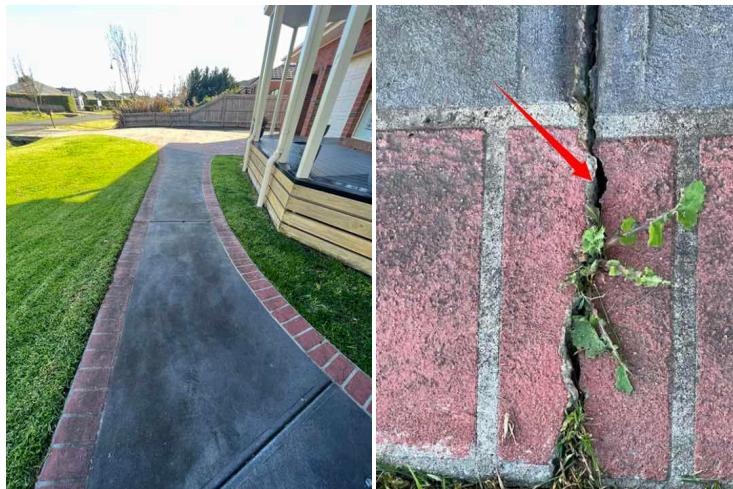
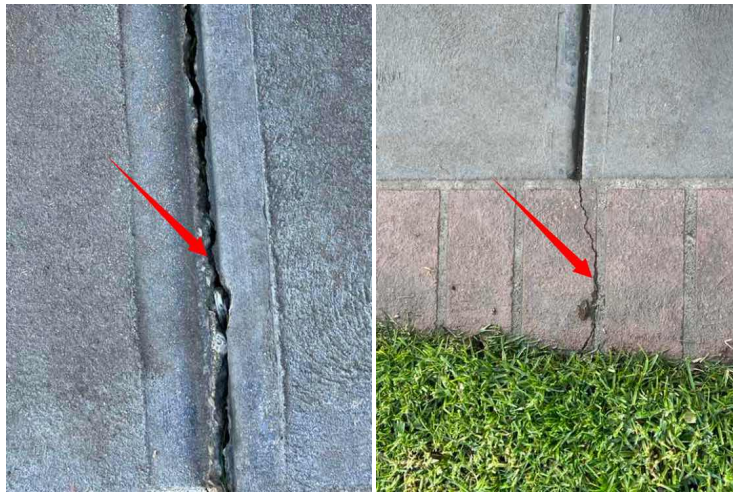
Pathways Condition

Common cracks and settlement were observed on paths. Whilst these cracks appeared to be typical at the time of inspection, we strongly recommend you monitor these cracks and if worsening occurs contact a concreter for further advice.

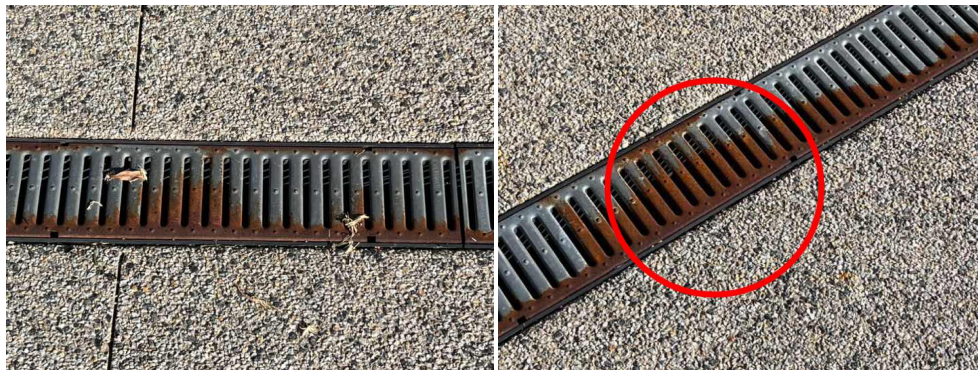
Drains

Surface rust on the steel drain by the swimming pool, replacement recommended.

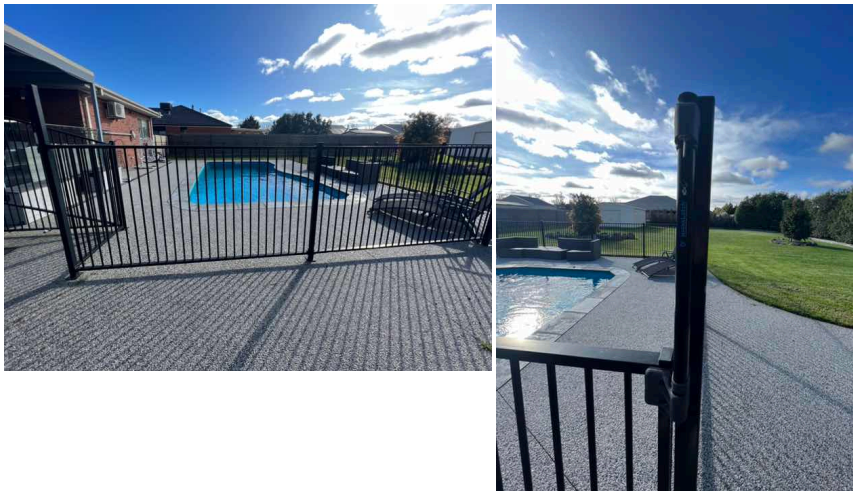
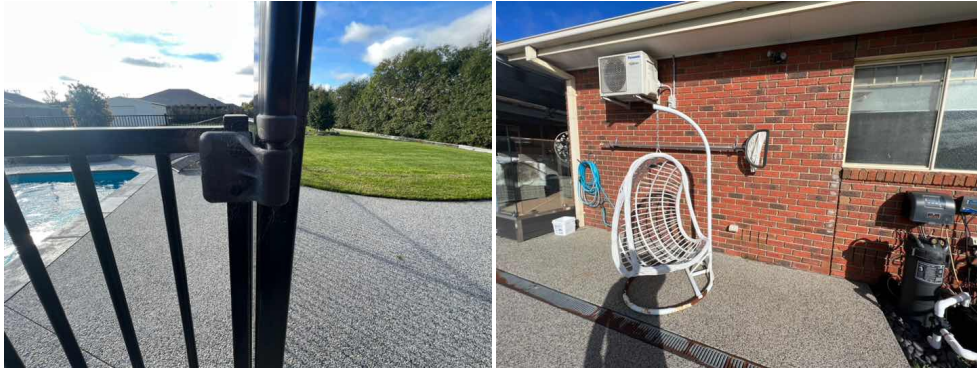
Recommend proving cover for the pool equipment to prevent deterioration.

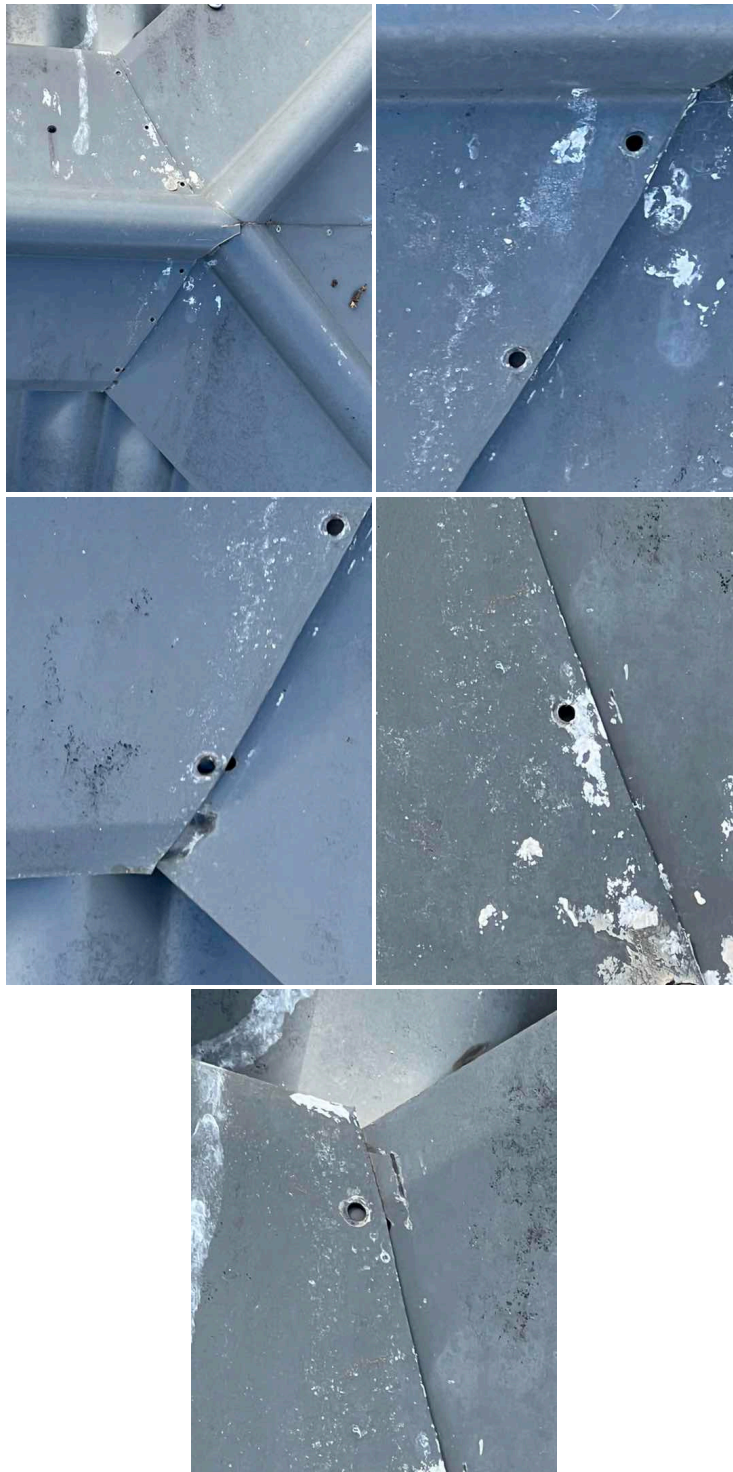
Missing pop rivets from various hip and ridge cappings, recommend licensed plumber repair.

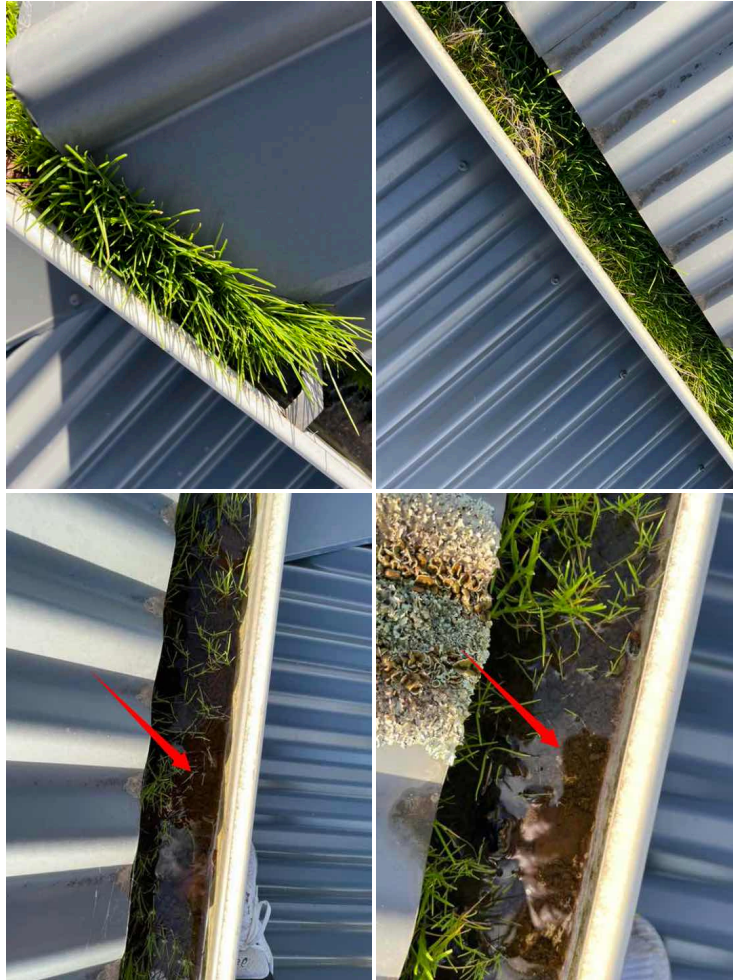
Gutter Findings

Debris in guttering areas- this requires cleaning out to prevent blocking of downpipes and leaking into eaves and fascia. Have gutters cleaned and assessed by a plumber for adequate fall. Regularly clean to prevent ponding. Ponding water will contribute to rust.

Gutter ponding - This can relate to poor fall, inadequate down pipes, gutter or debris build up. If debris presence has been noted above clean same out and re-assess for any ponding. If clean guttering is ponding it can be a blocked down pipe or the guttering fall is inadequate. A qualified roof plumber should be engaged for advice and recommendations.

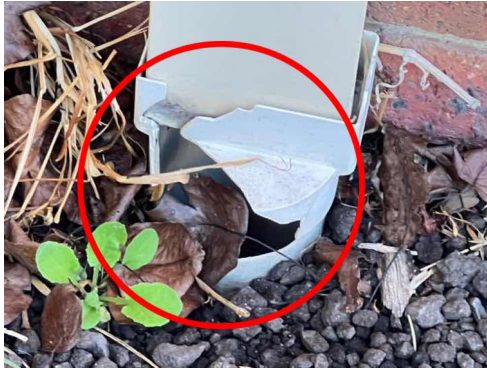
Downpipe Findings

The downpipe base is inadequately aligned at ground pipe. This has the potential to cause debris blockage. A qualified plumber should be engaged for repairs and recommendations.

The downpipe/s wall clips is detached or missing. Although minor and easily rectifiable, we recommend a licensed roof plumber be engaged for repairs.

Recommend installing caps to all unused drains, this will prevent debris entering and causing blockages.

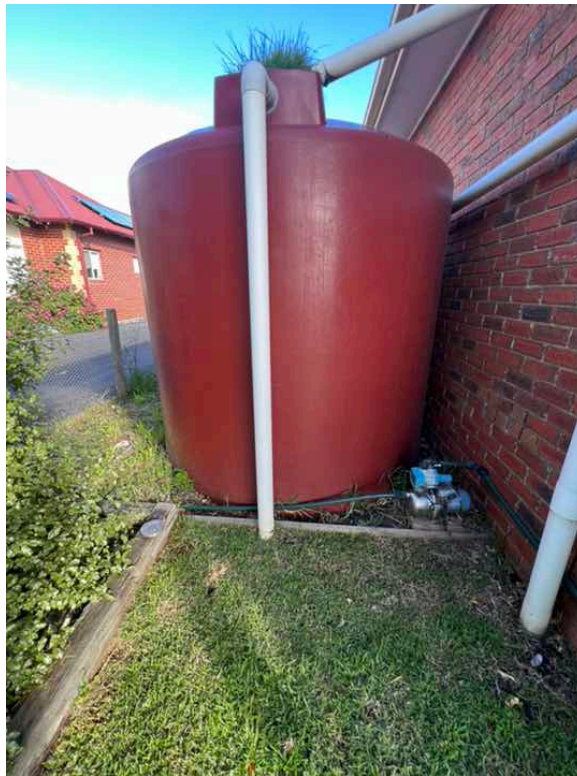
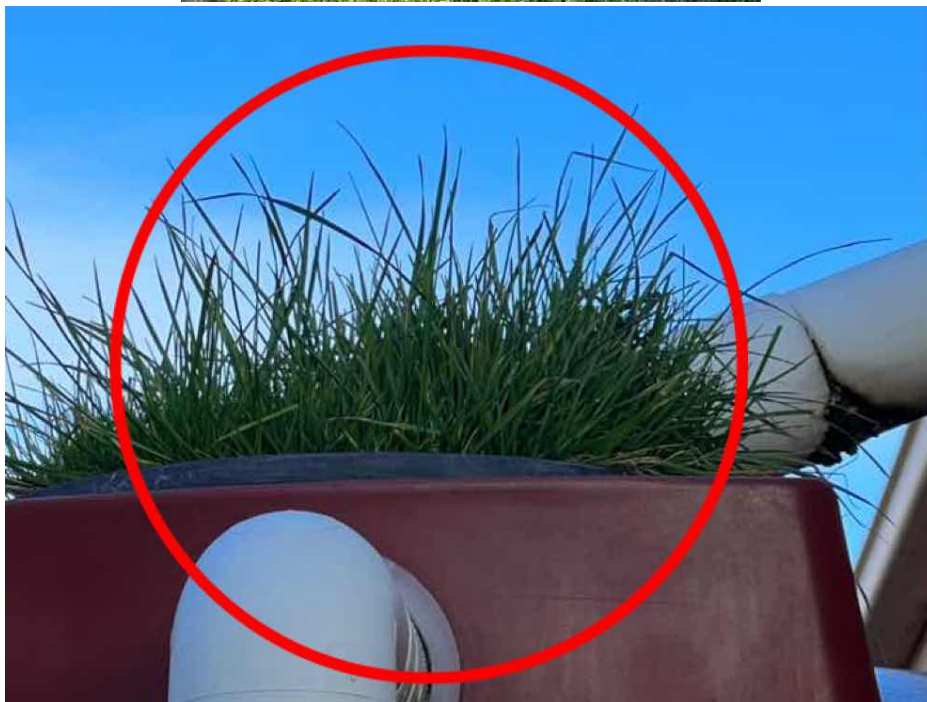
Water Tank Condition

Debris on the top inlet, recommend cleaning.

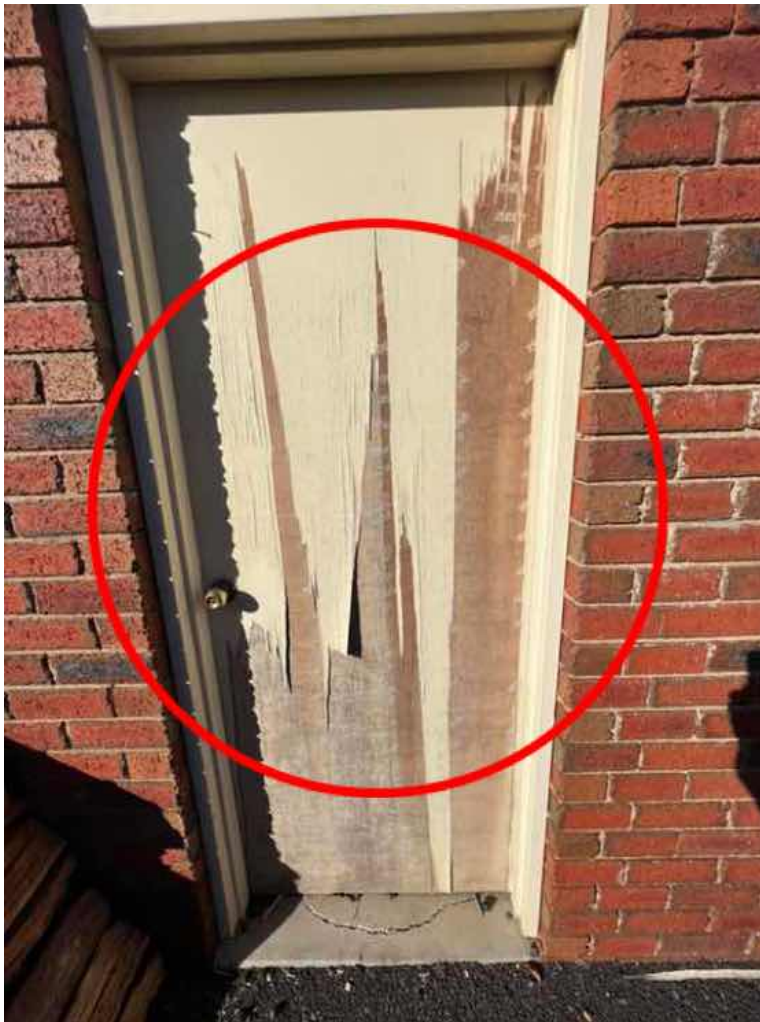
Door Findings

The garage pedestrian door is weathered and deteriorated, recommend licensed carpenter replace.

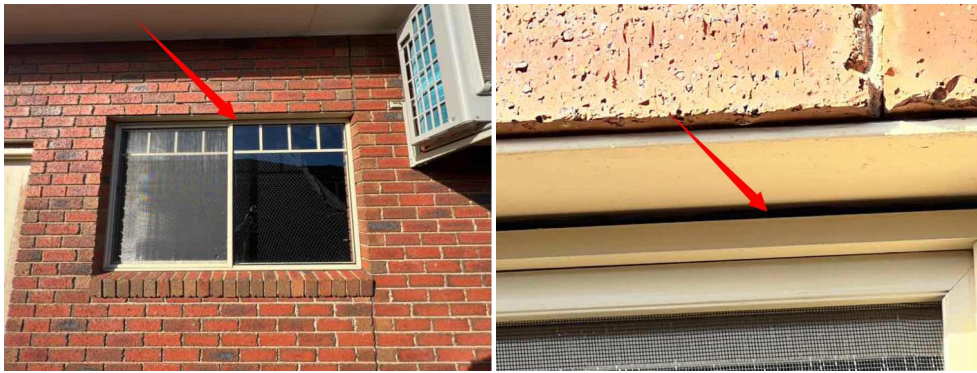
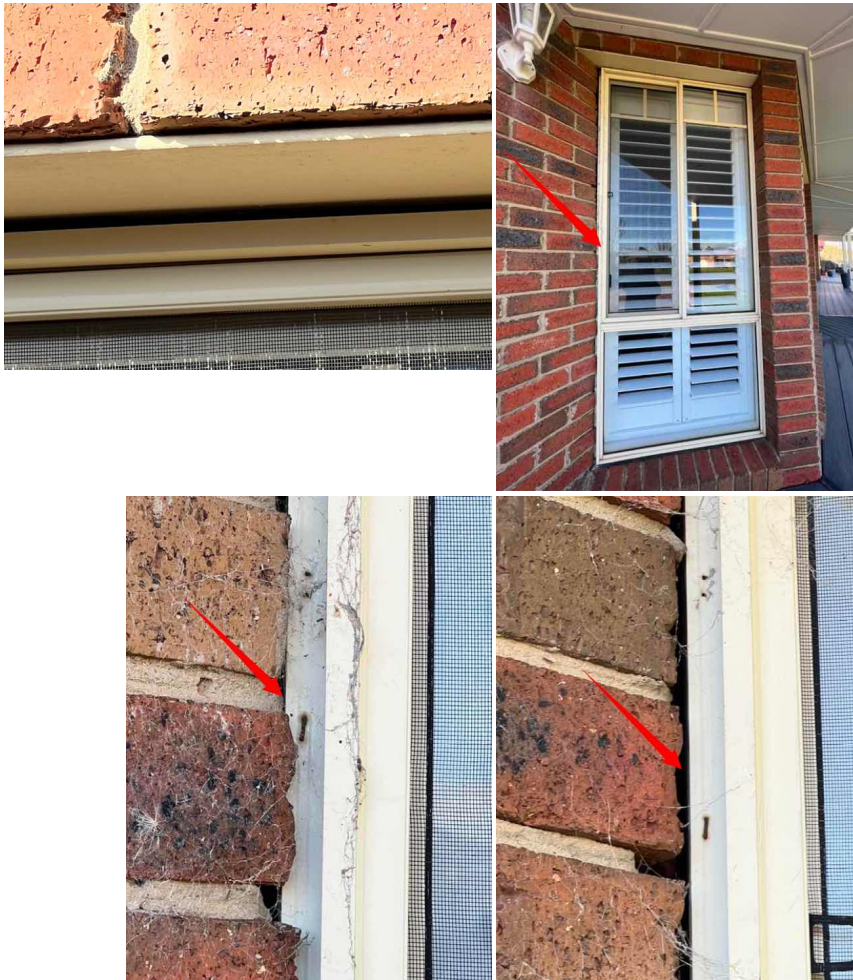
Gaps between window frame and wall cladding evident - This can be due to poor workmanship, wall movement, footings settlement. A qualified carpenter should be engaged for advice and recommendations.

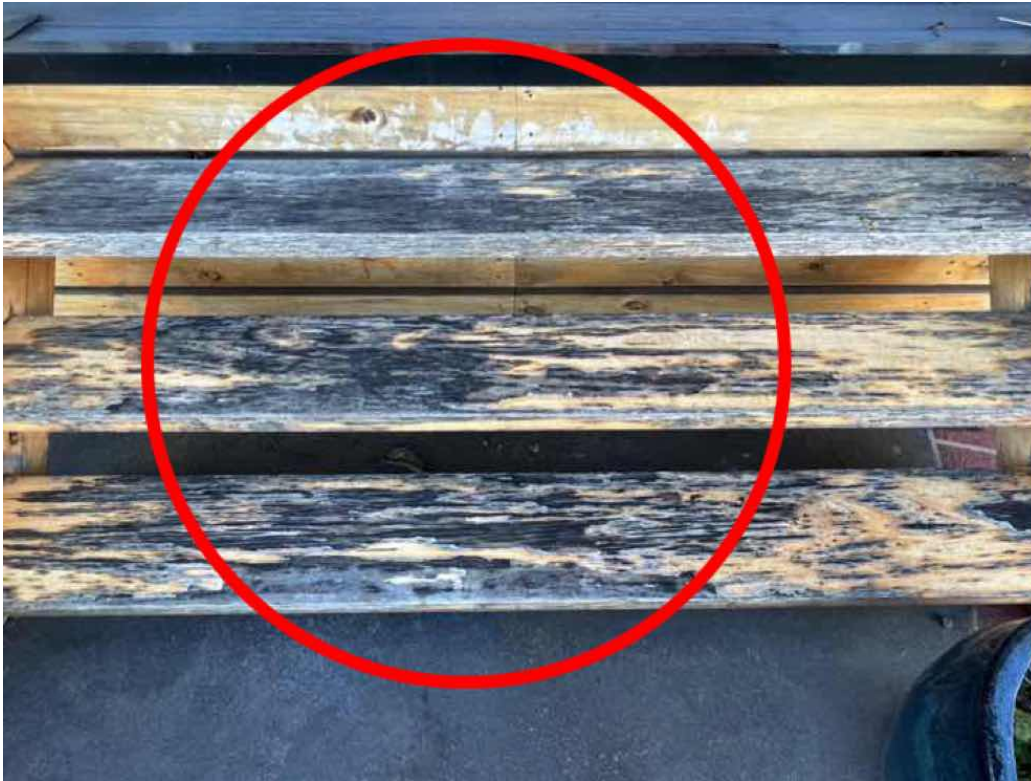
General maintenance required to the front timber steps, recommend re sealing to prevent deterioration.

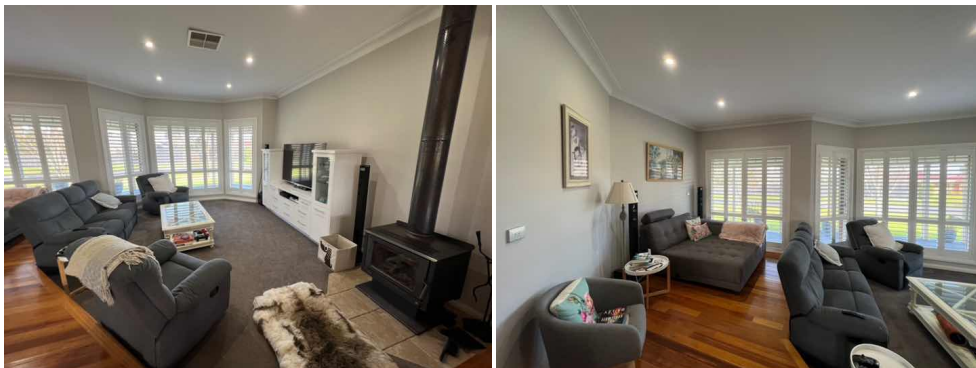
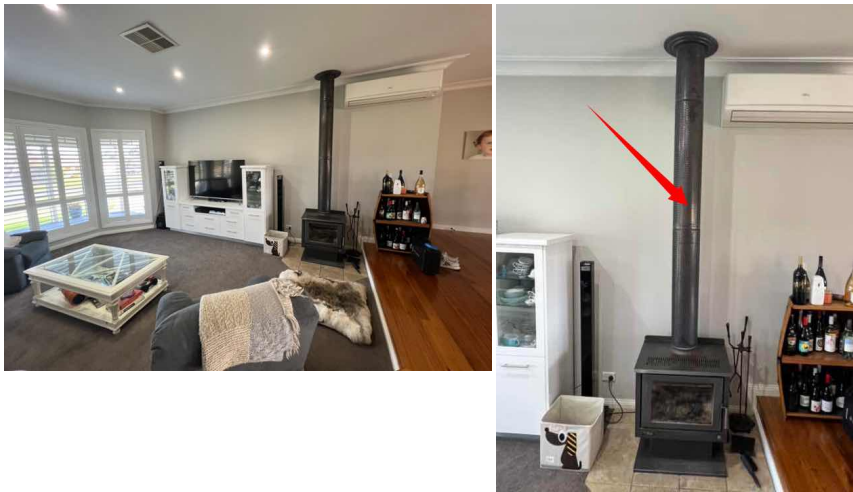
Living Room

Although serviceable I recommend having a licensed plumber check the fire flue to determine if it's clean and clear.

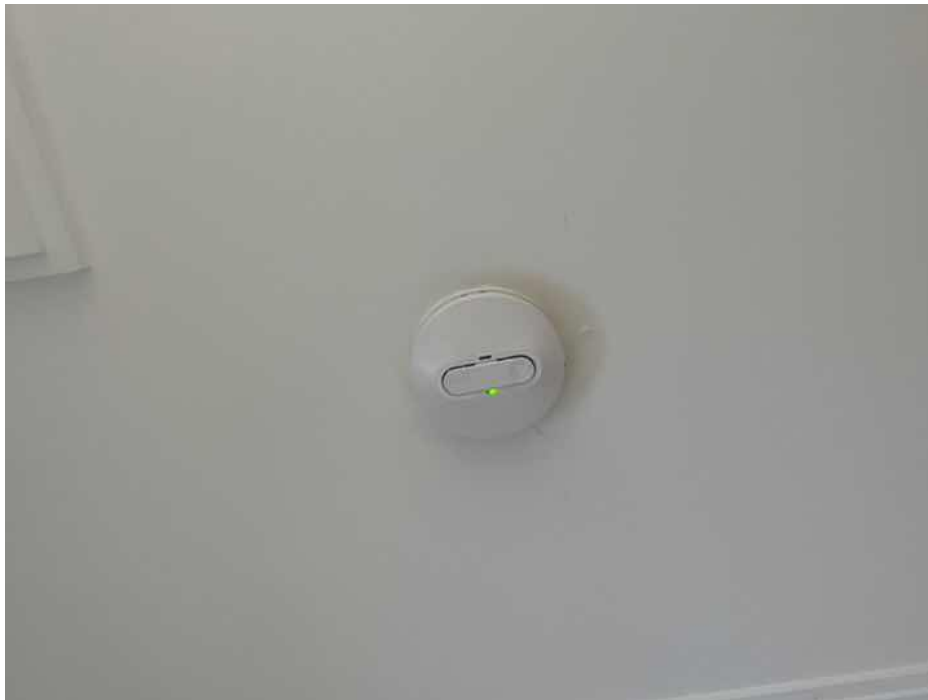
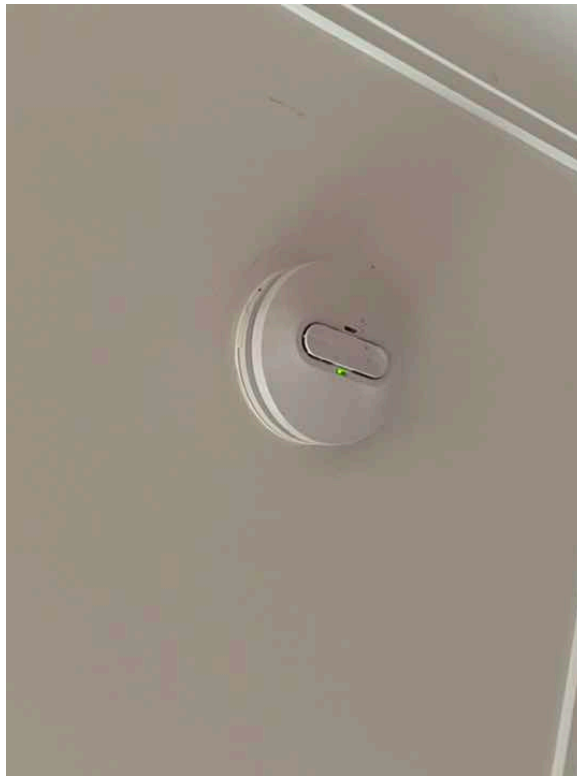
Was a Smoke Alarm Fitted

The rear room appears to have been converted into a bedroom but a smoke alarm hasn't been installed outside of this room, recommend licensed electrician install ASAP.

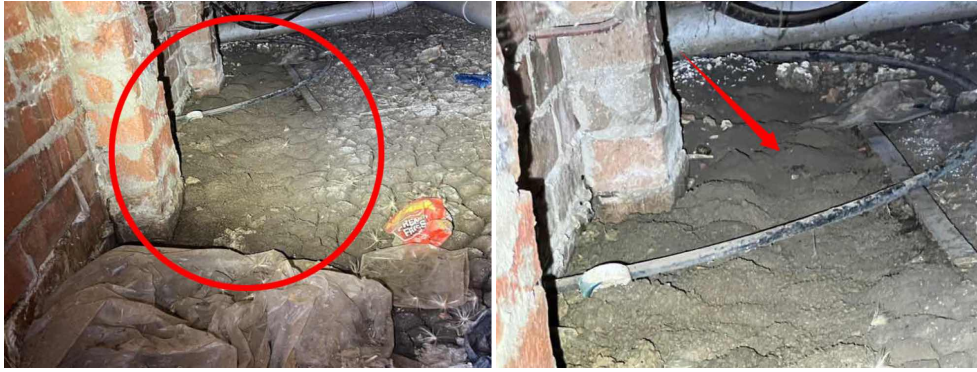
Dampness in sub floor soil. Damp sub floor soil should be avoided as it can cause fungal decay, mould and possibly footings problems. Recommendations: A qualified drainage plumber should be engaged for advice and recommendations.

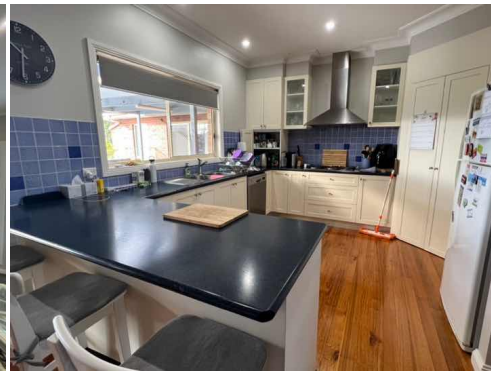
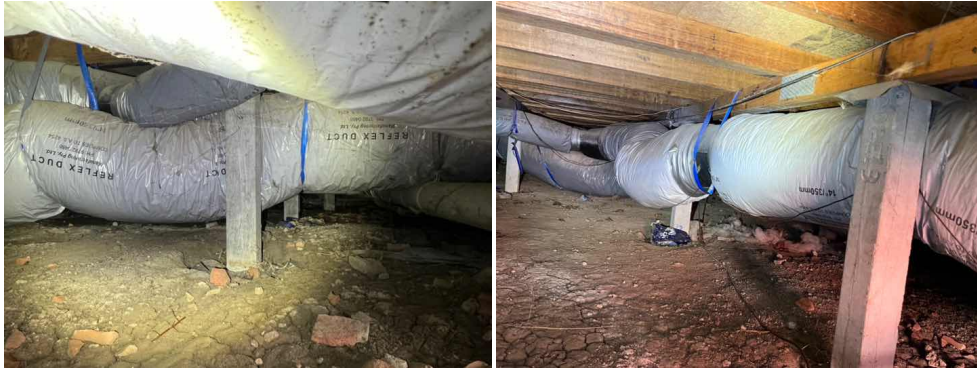
There is duct work present throughout the subfloor which is preventing a full/thorough visual inspection taking place. It is strongly recommended that full access be granted to enable a thorough inspection to take place as it could be harbouring timber pest activity and/or damage.

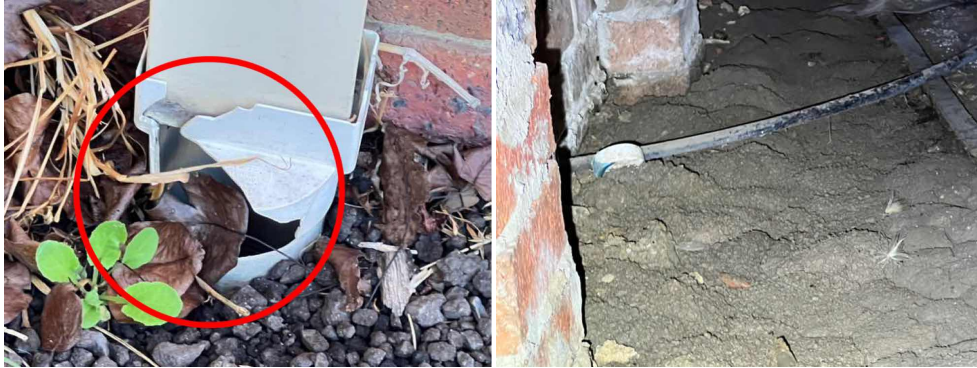
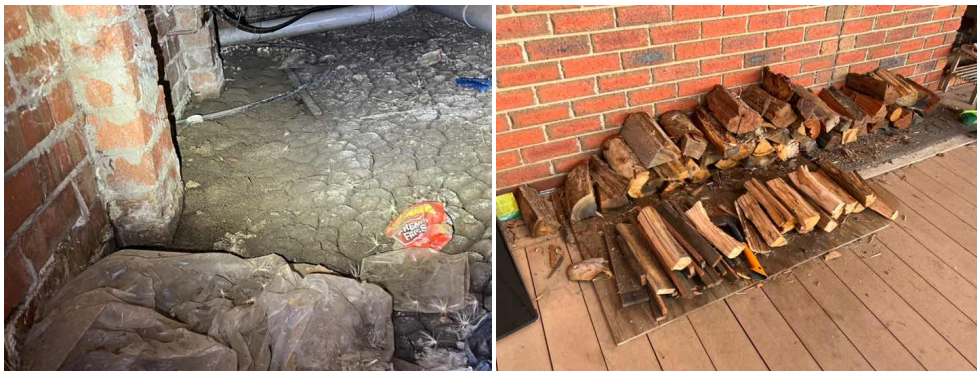
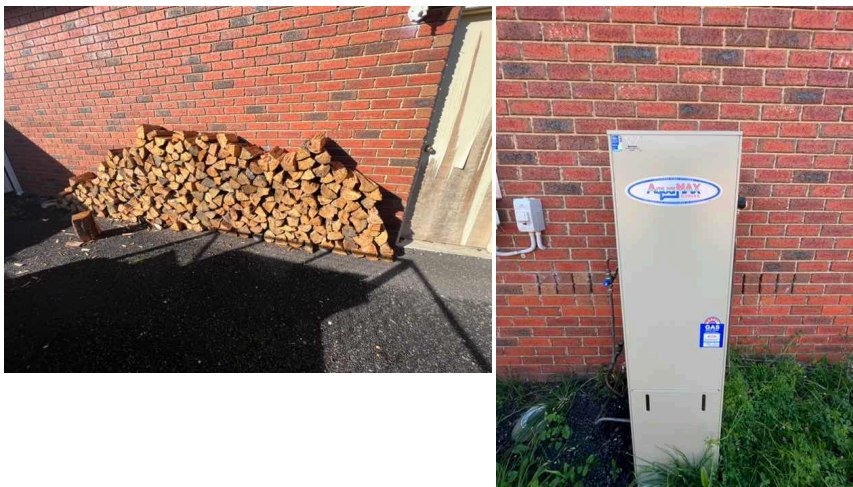
Timber fire wood and off cuts in contact with ground. This provides conducive and concealed entry conditions and concealed entry for termite infestation. Remove and store above ground surface.

Hot water unit overflow not connected to drain. This provides conducive conditions for termite infestation.
