Building and Timber Pest Inspection Report

Sample Place, Melbourne, VIC, 0000

Report/Agreement #	2906230215037
Inspection Date:	29 Jun 2023
Inspection Time:	02:15 pm

Pest And Building Inspection

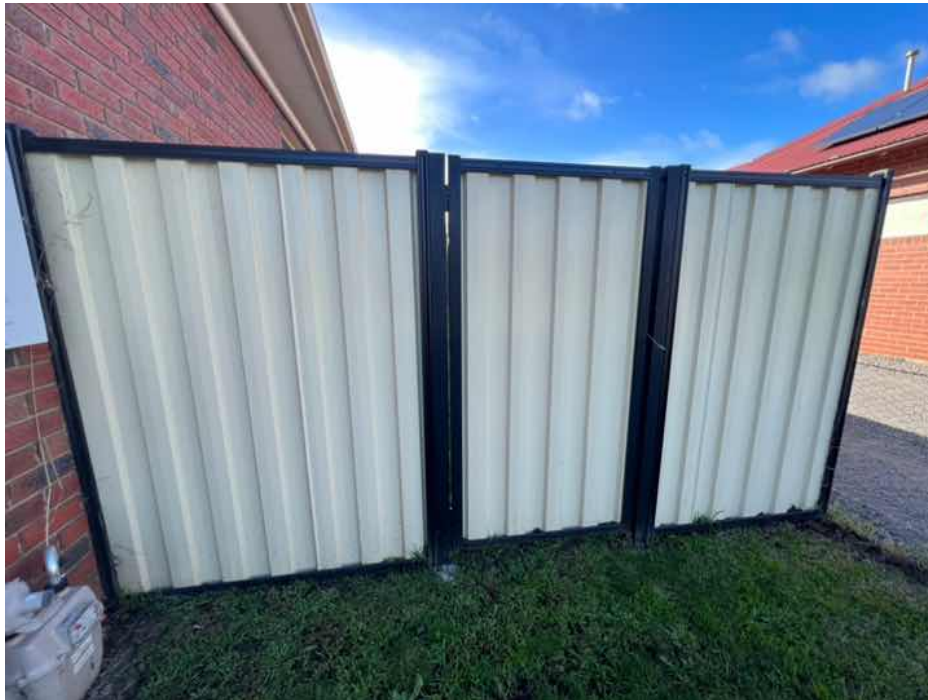
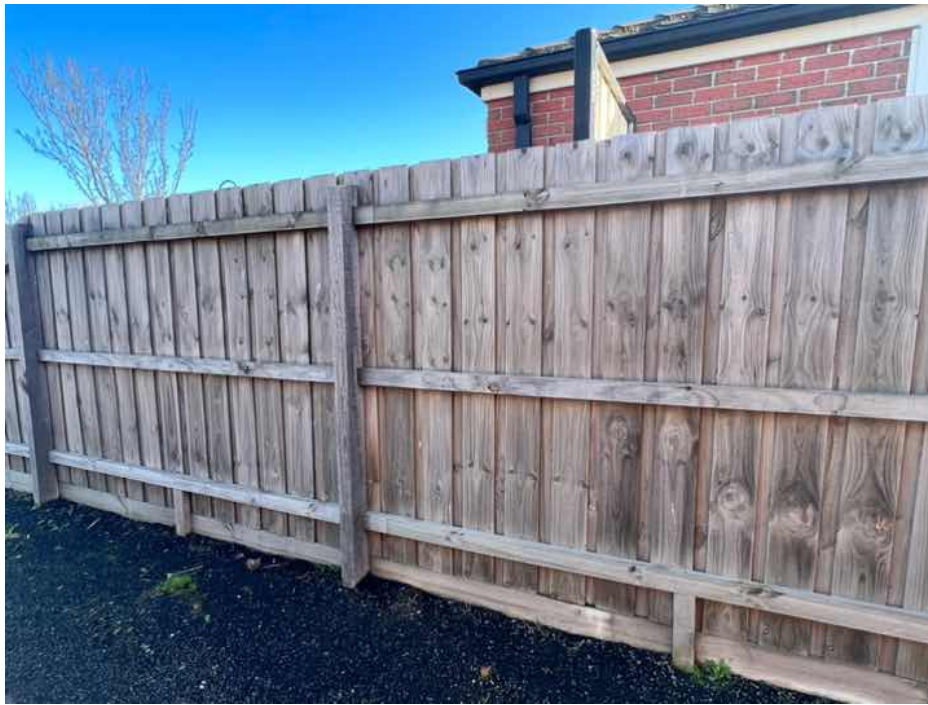
Overall Condition

Of the visible areas, the general condition of the fences and gates is serviceable for the age of dwelling.

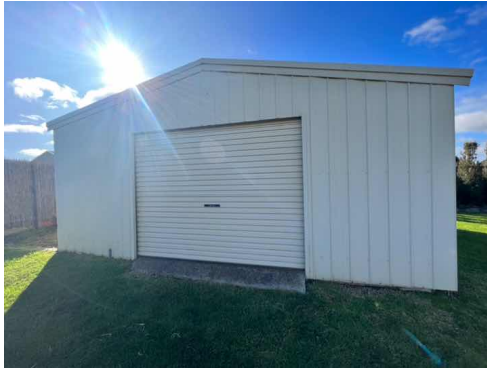
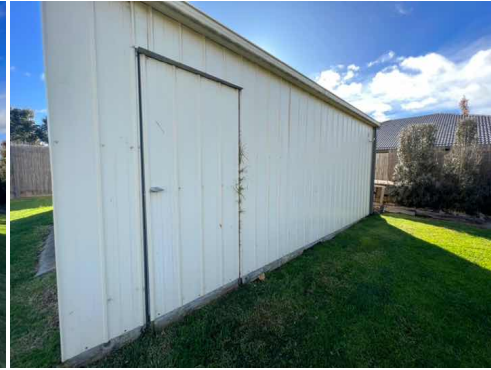
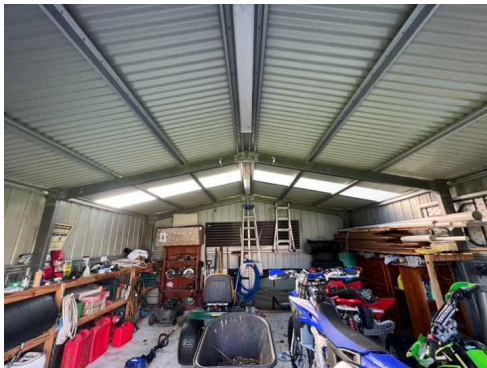
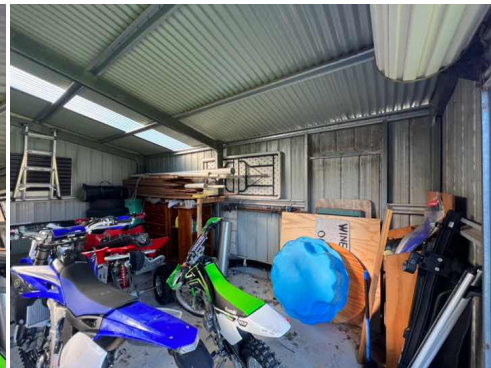
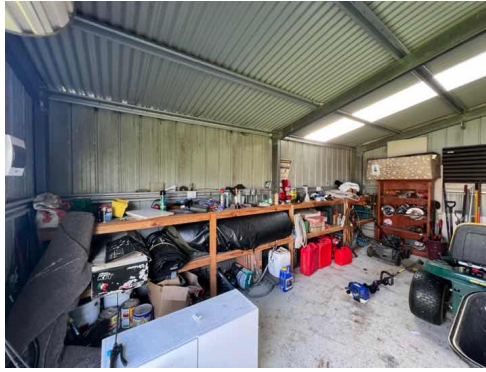
Shed Condition

The shed is in fair usable condition.

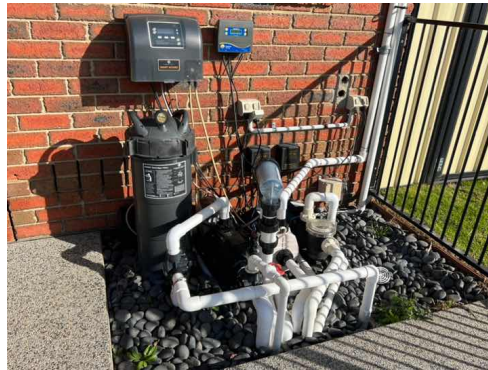
Recommend proving cover for the pool equipment to prevent deterioration.

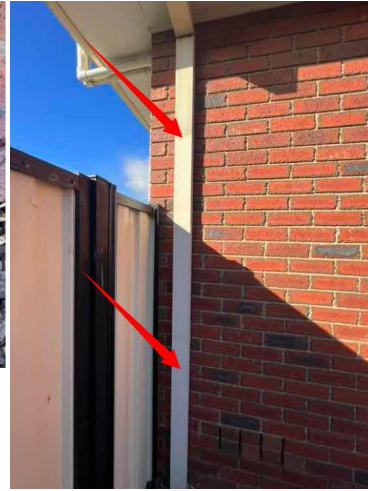
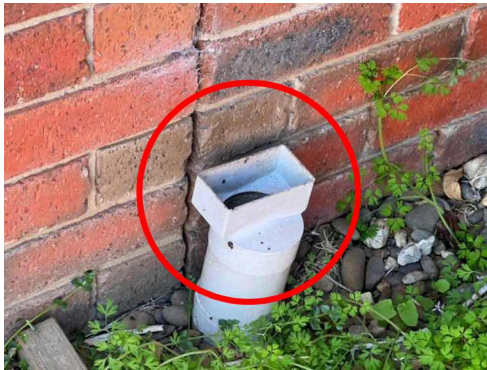
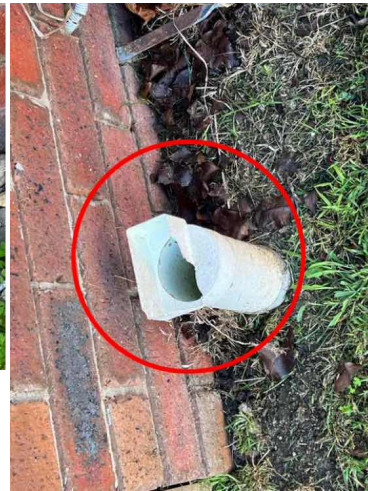
The downpipe/s wall clips is detached or missing. Although minor and easily rectifiable, we recommend a licensed roof plumber be engaged for repairs.

Recommend installing caps to all unused drains, this will prevent debris entering and causing blockages.

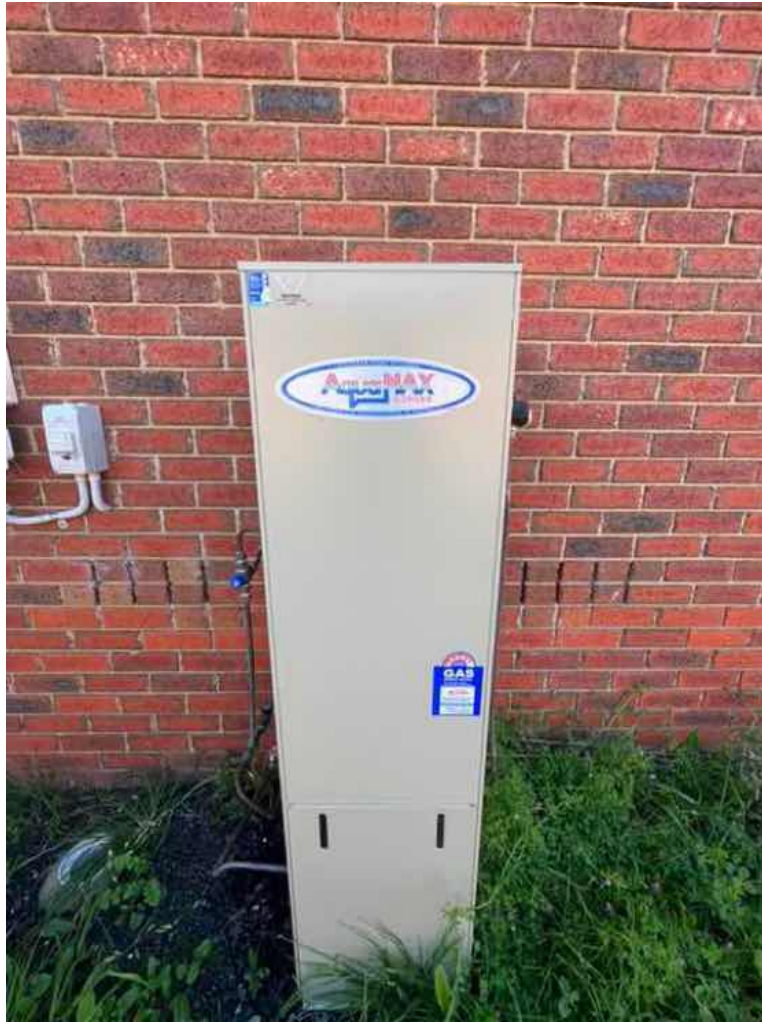
Hot Water Unit Findings

The hot water system appears to be in a serviceable condition. No specific tests other than running the hot water from a tap was carried out. No determination has been made as to the suitability or adequacy of the hot water system in relation to capacity or otherwise.

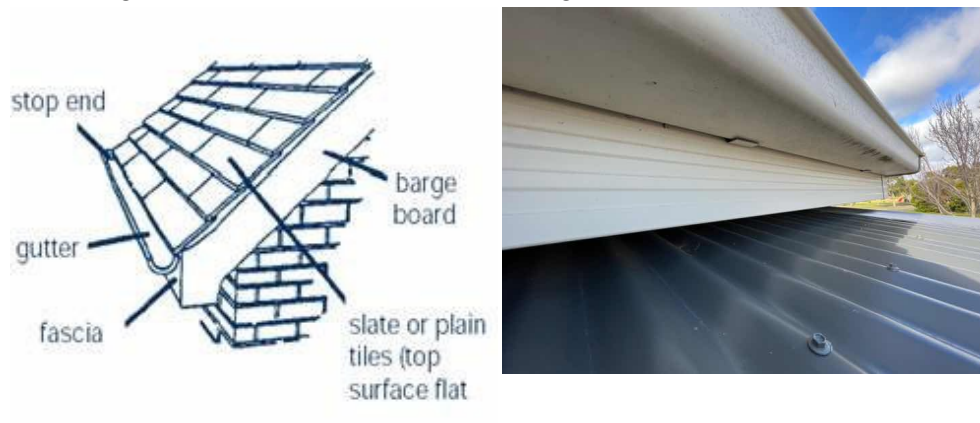
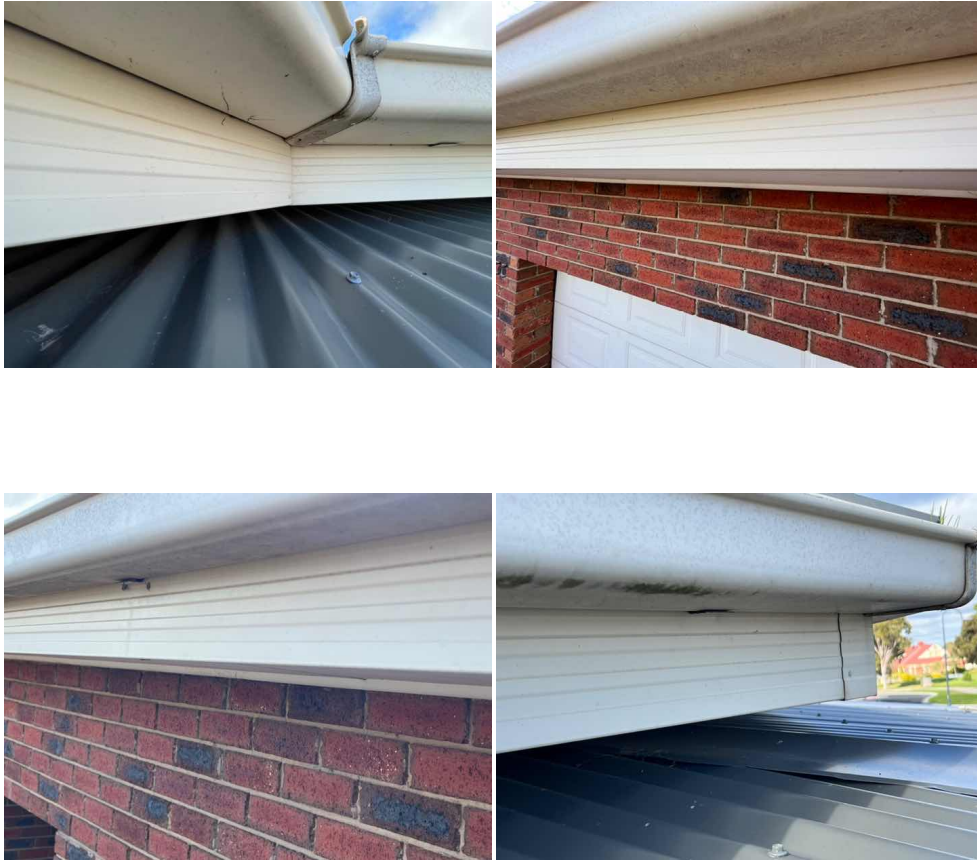
Condition

On visual inspection, the general condition of the fascia/barge boards is serviceable.

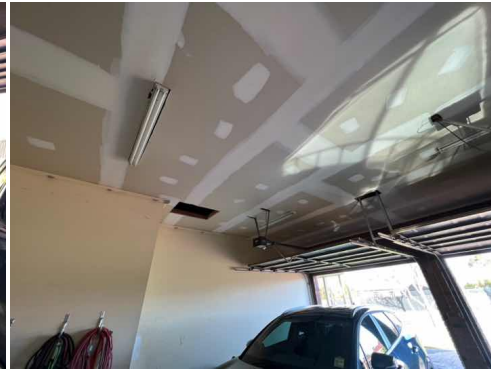
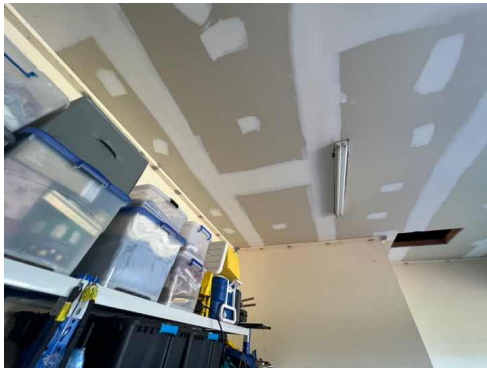
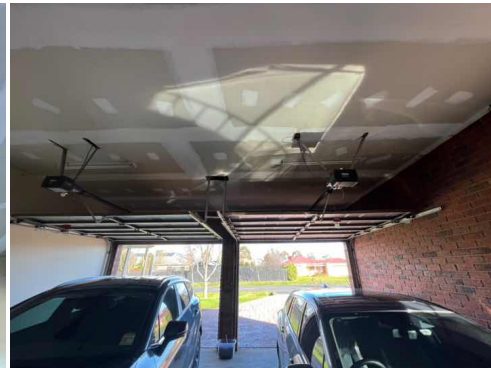
Ceiling Findings

The garage ceiling hasn't been painted, recommend painting.

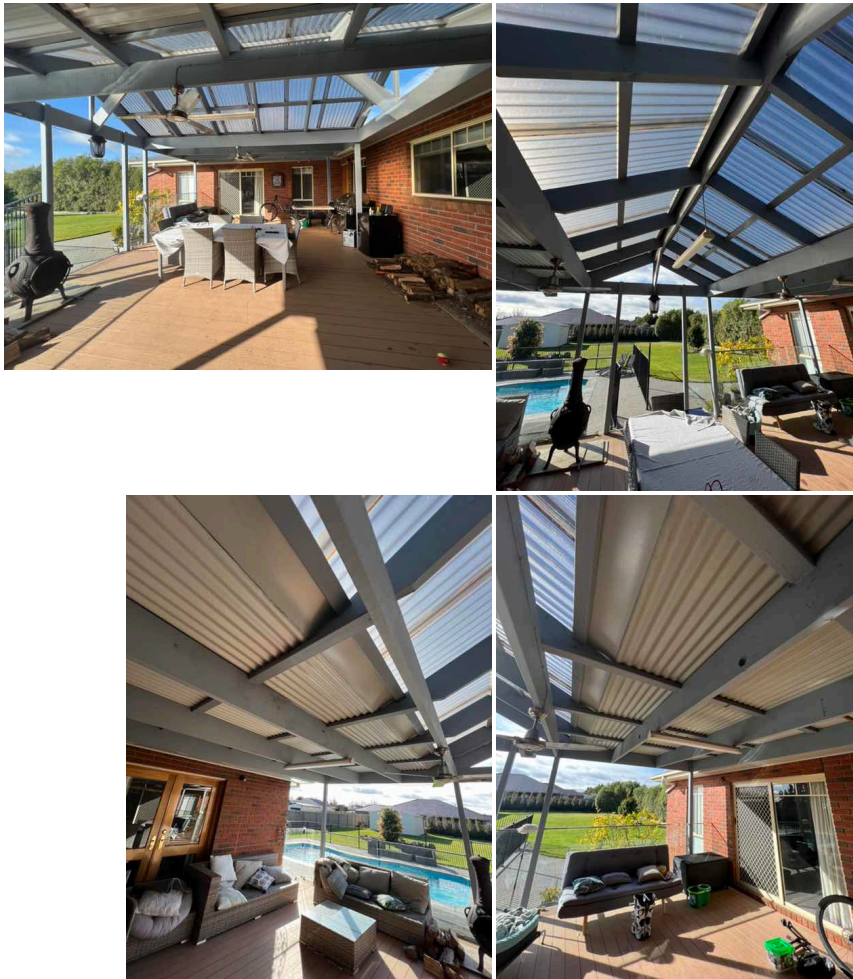
Pergola Findings

The Pergola is in a serviceable condition with no notable defects sighted.

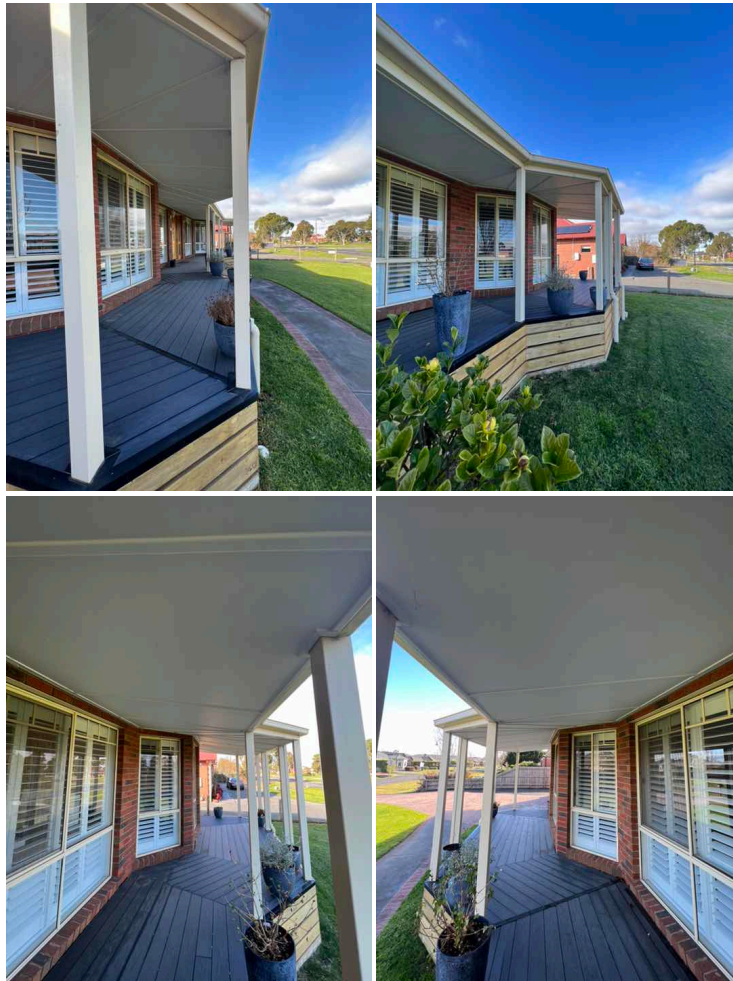
Verandah Findings

Though we are not structural engineers the veranda/s appear to be in a serviceable condition.

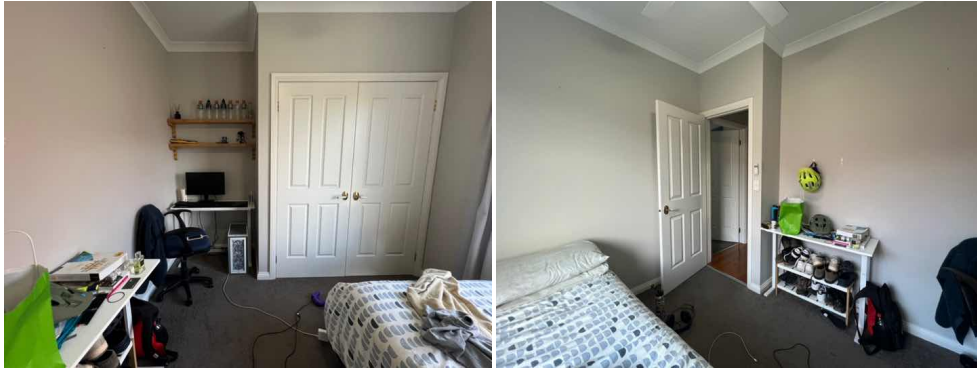
Other Doors

Other doors such as sliding , side entry etc.. appear to be in serviceable condition.

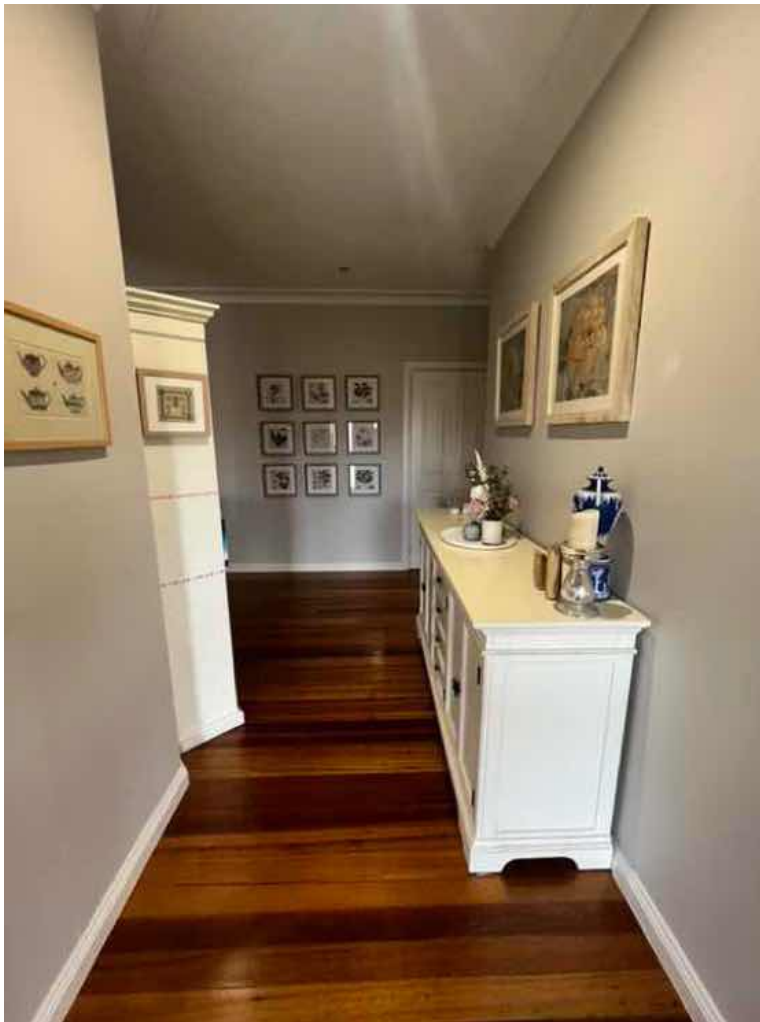
Living Room

From the visible and accessible areas, this room appears to be in a serviceable condition for the age of the property with no notable structural defects sighted.

Although serviceable I recommend having a licensed plumber check the fire flue to determine if it's clean and clear.

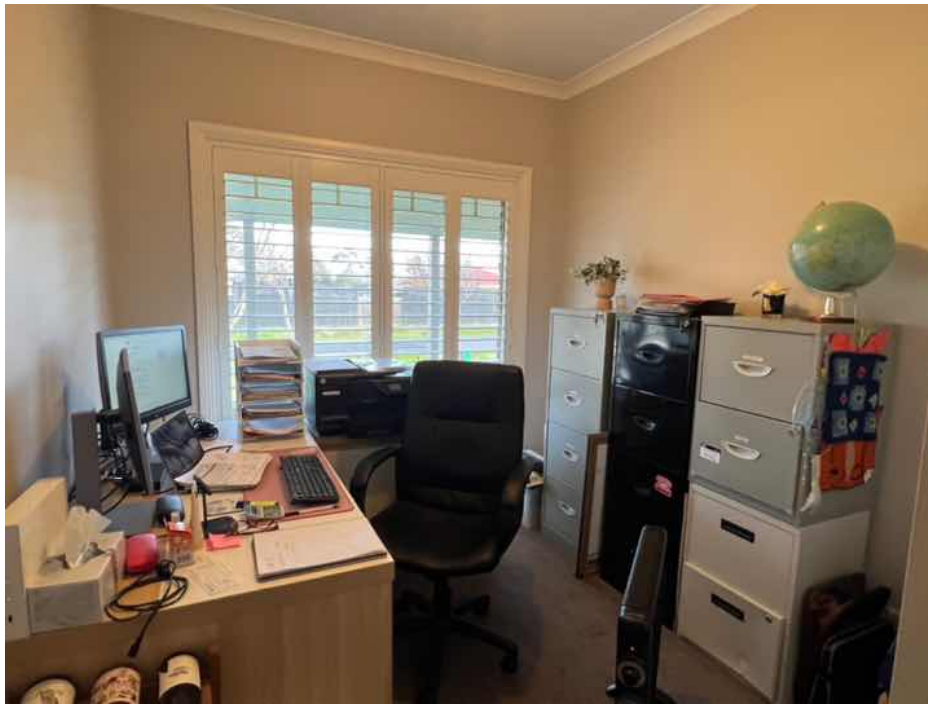
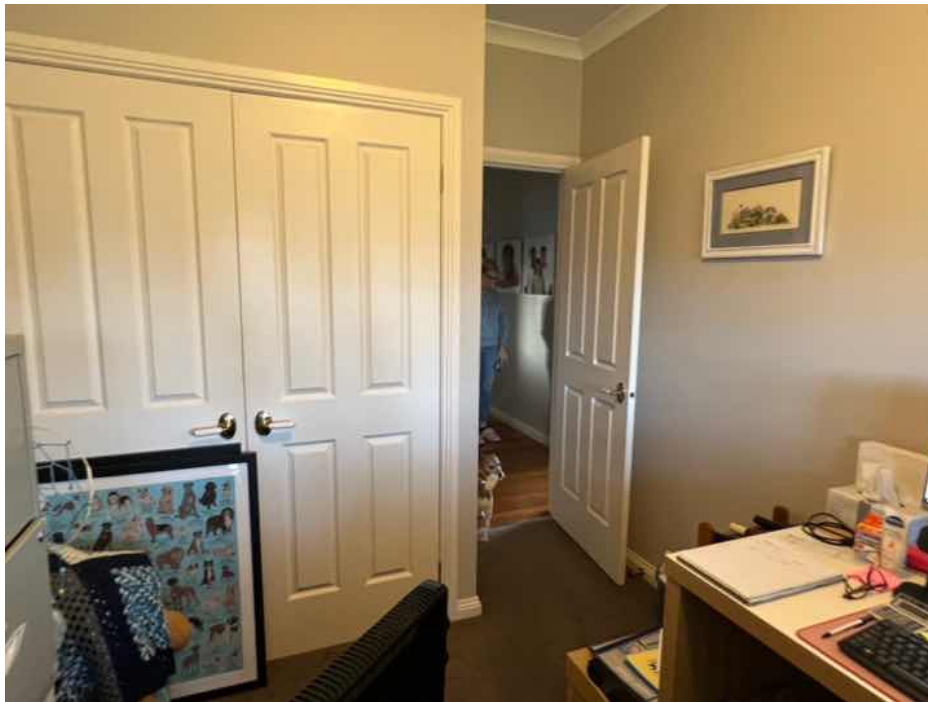
Hallway/s

From the visible and accessible areas, the hallway/ appears to be in a serviceable condition for the age of the property with no notable structural defects sighted.

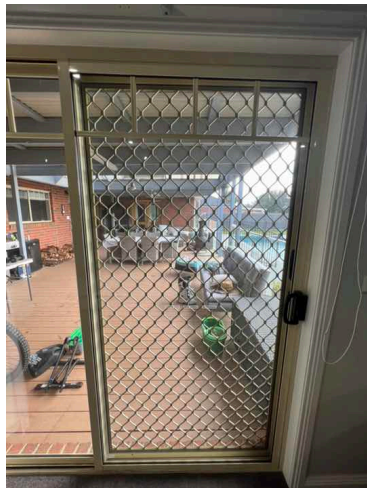
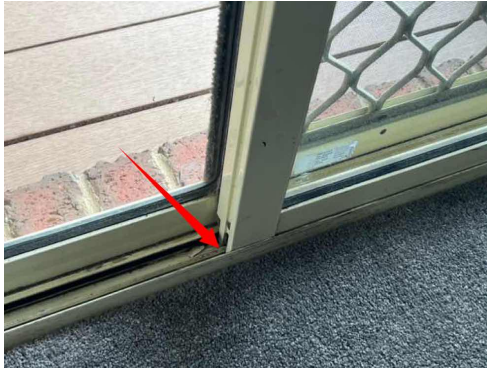
Various windows/Sliding Doors require adjustment for smooth operation, this may require replacing the rollers, recommend licensed carpenter repair.

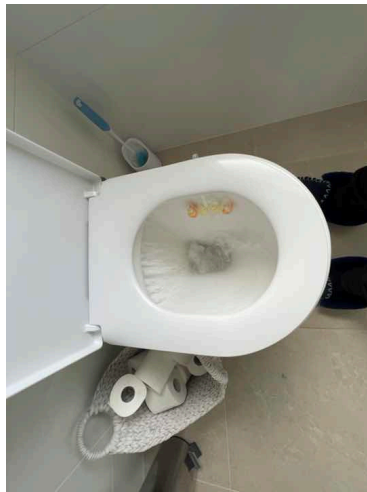
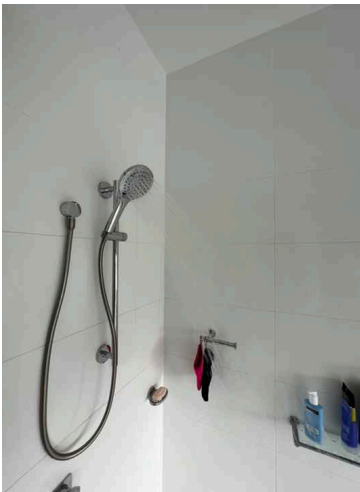
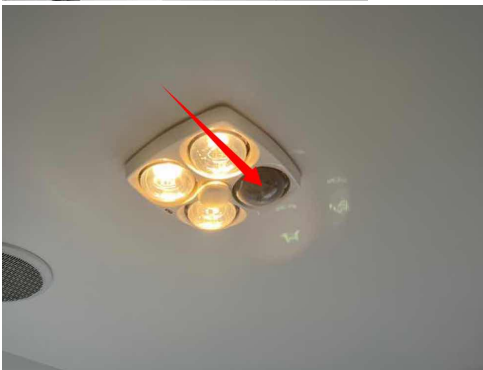
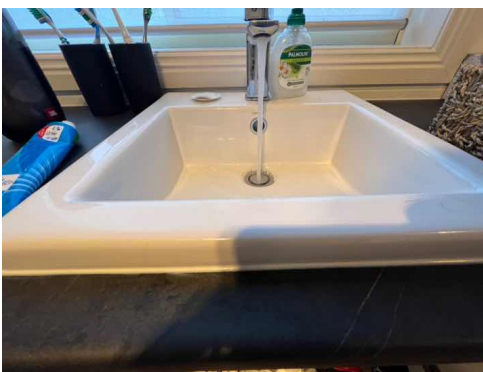
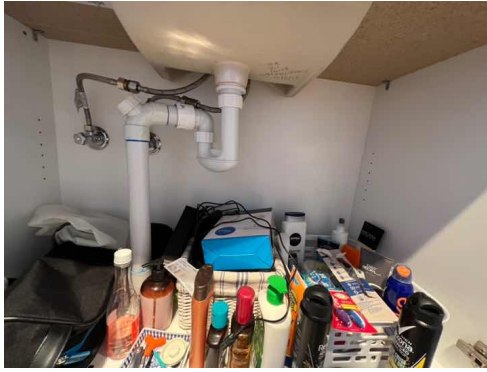
Bathrooms 1 & 2

Of the visible areas, the general condition of this bathroom is serviceable or in reasonable condition for age of dwelling.

A lamp globe in the ensuite has blown, recommend licensed electrician replace.

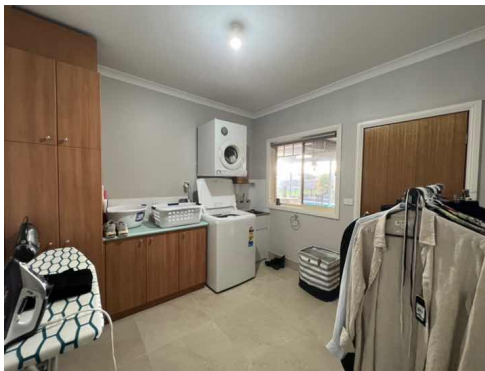
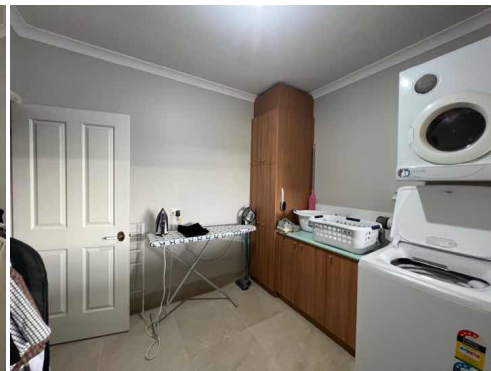
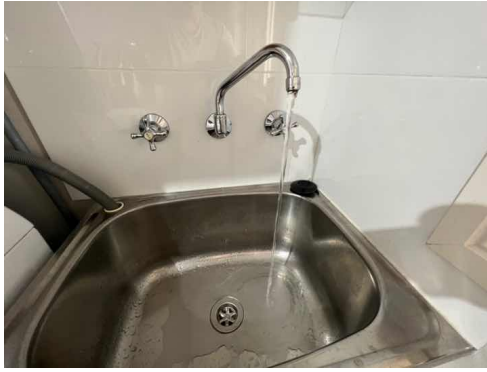
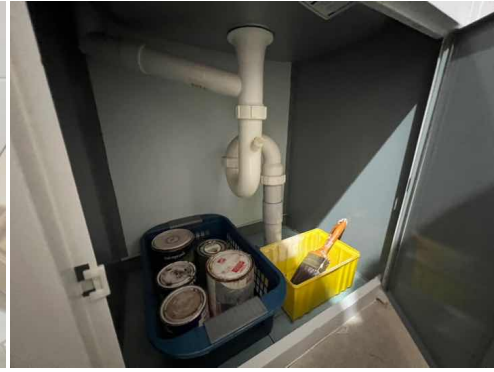
Laundry

Of the visible areas, the general condition of the laundry is serviceable or in reasonable condition for age of dwelling.

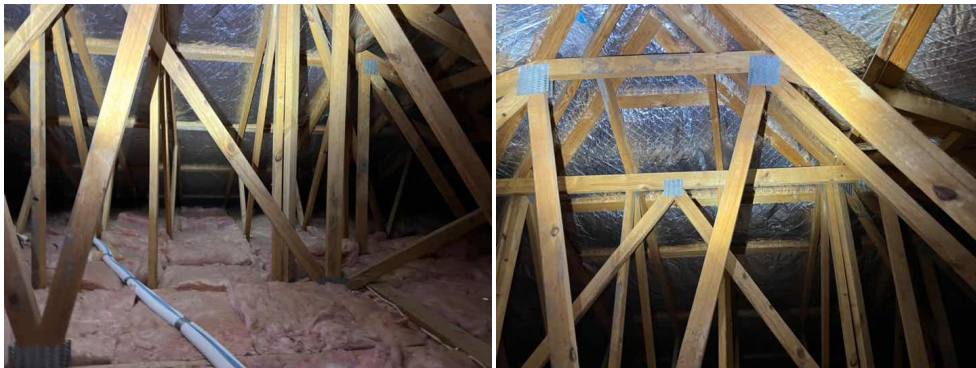
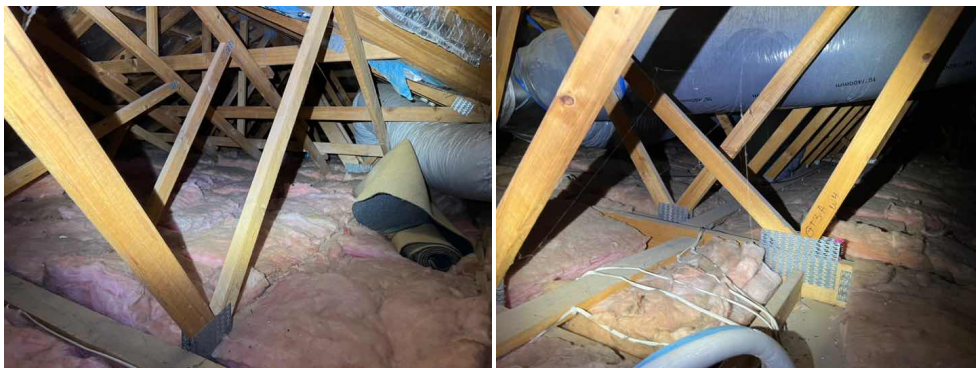
Visible sections of the roof void is in a serviceable condition for age of this dwelling.

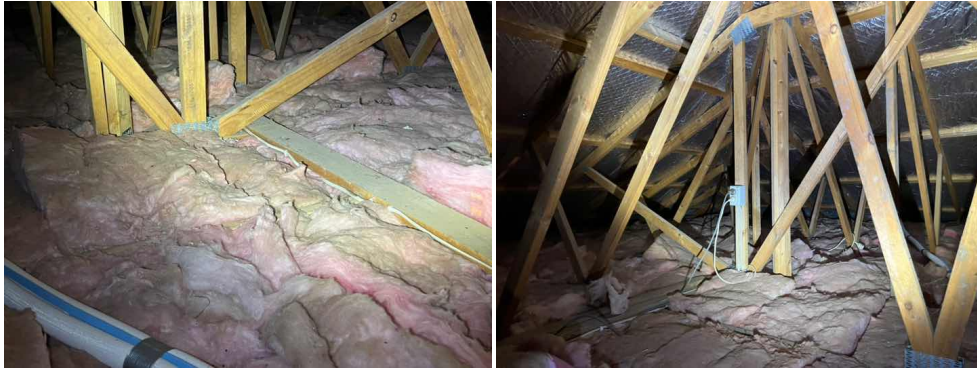
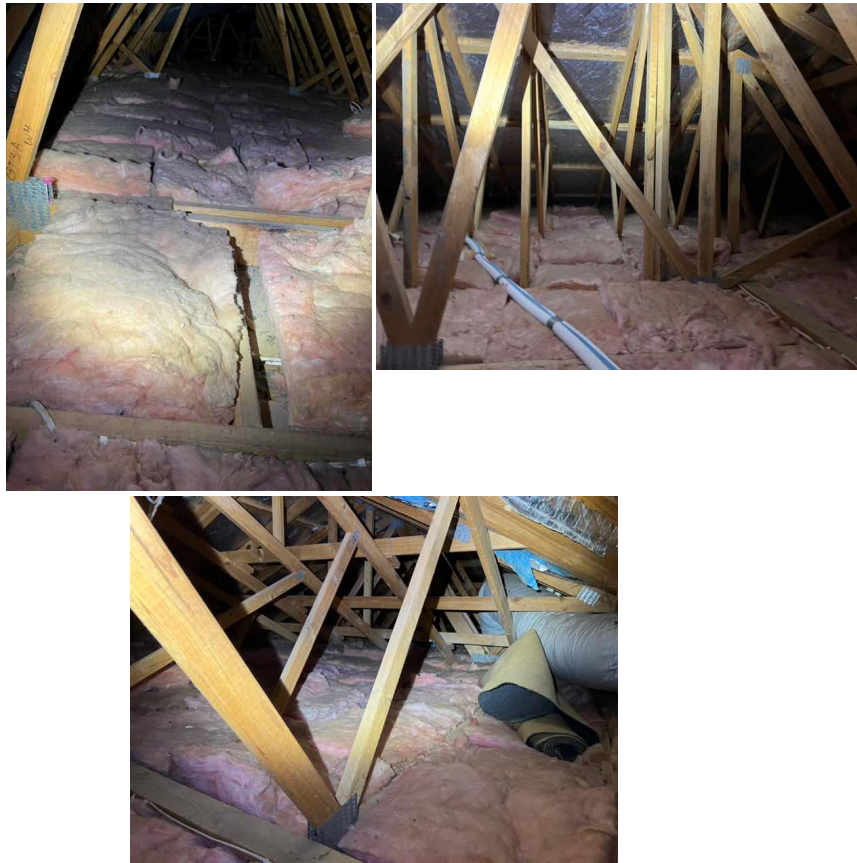
Insulation

Where visible and accessible, the insulation appears to be in a serviceable condition.

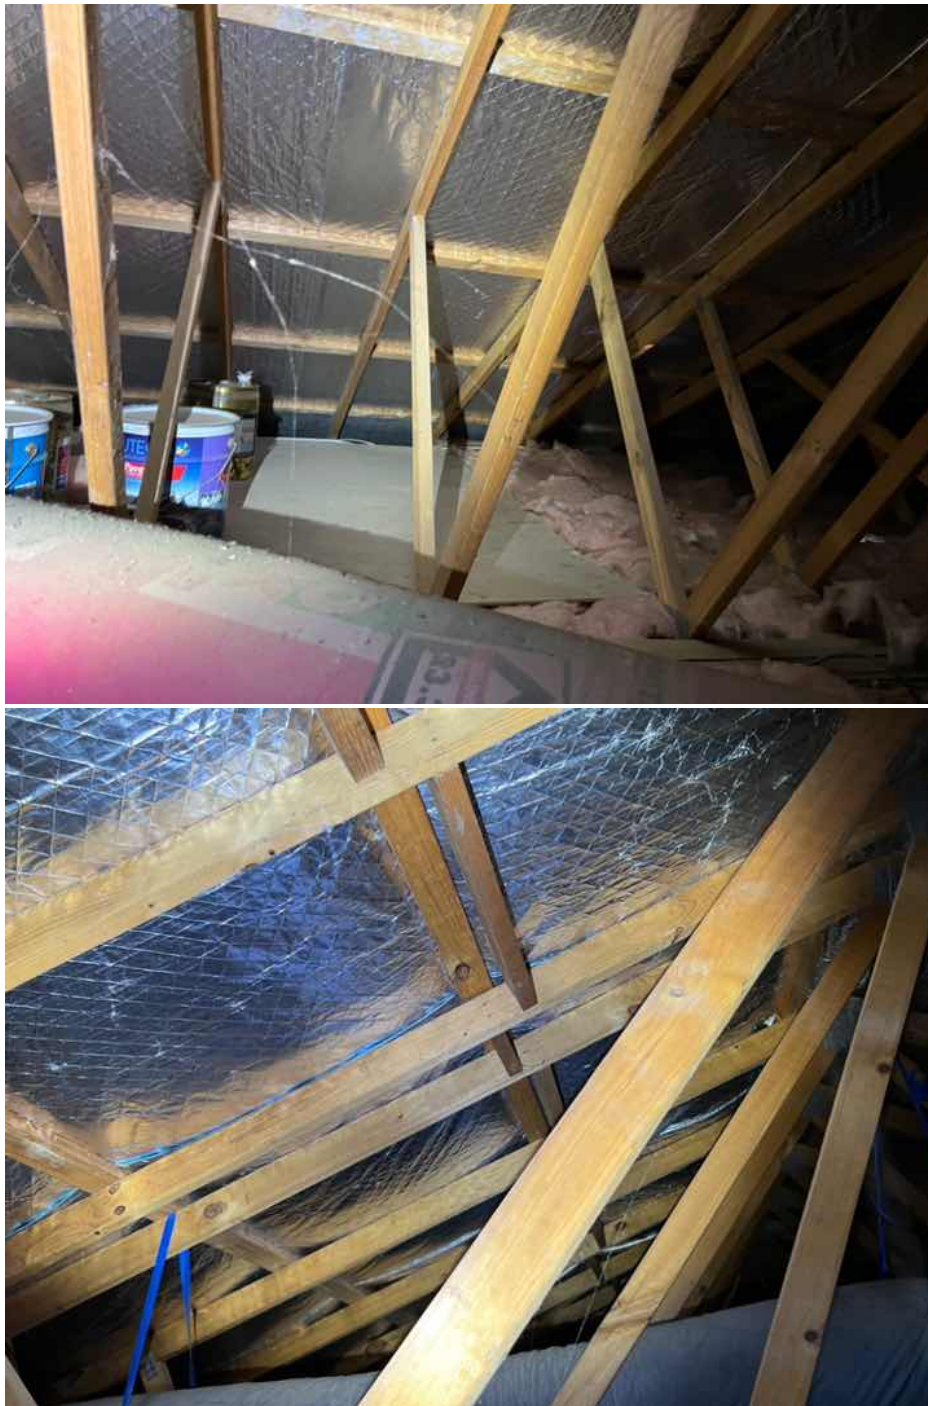
Sarking

The sarking generally is in a serviceable condition.

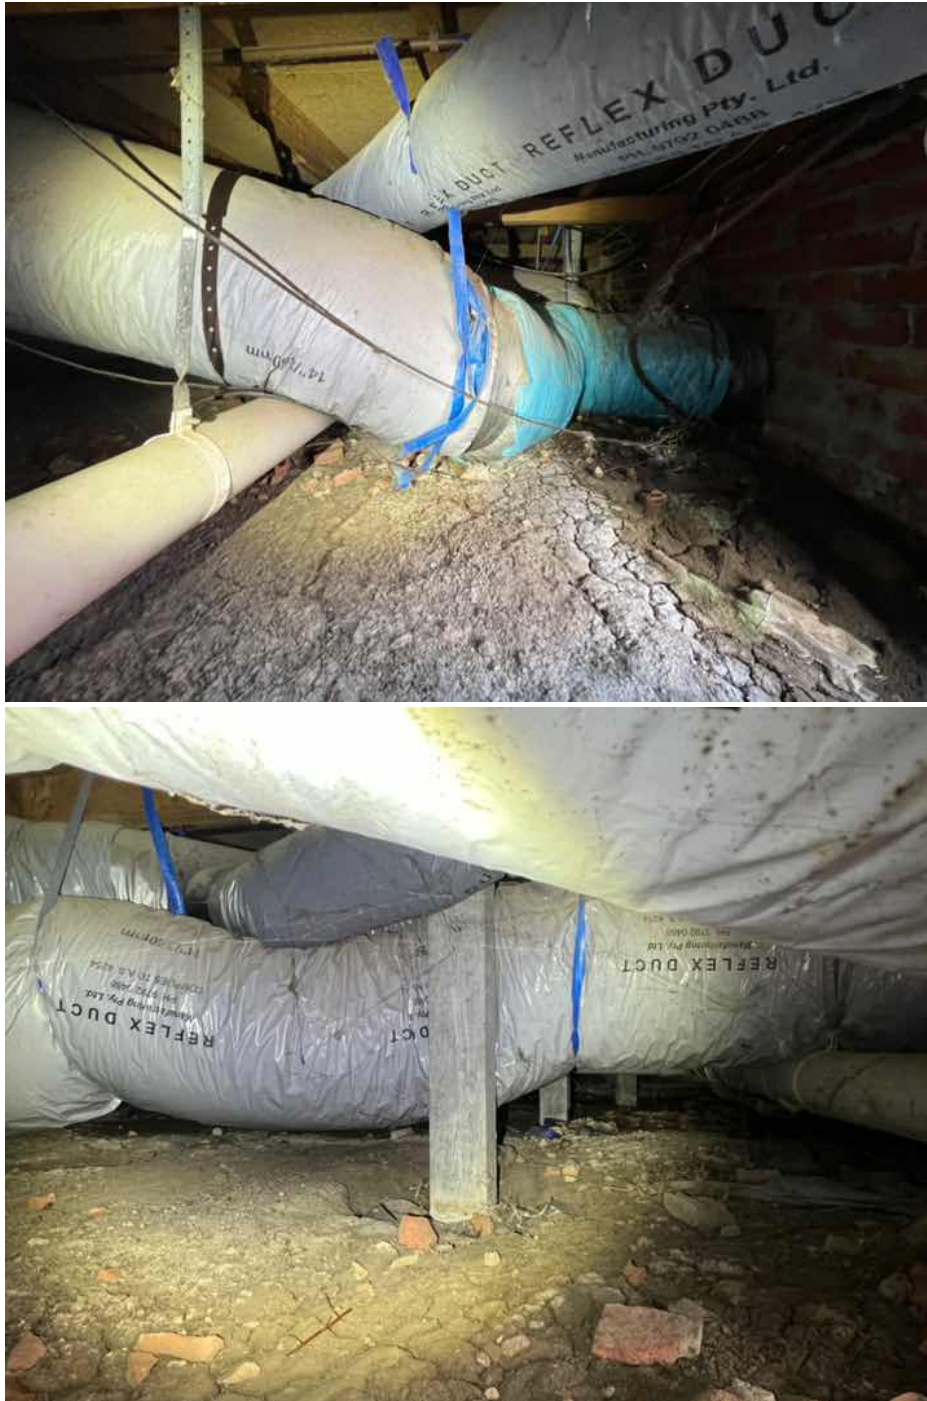
Heating ducts obstructing full inspection of subfloor.

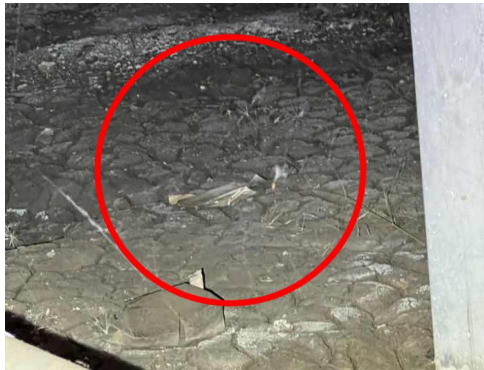
Dampness in sub floor soil. Damp sub floor soil should be avoided as it can cause fungal decay, mould and possibly footings problems. Recommendations: A qualified drainage plumber should be engaged for advice and recommendations.

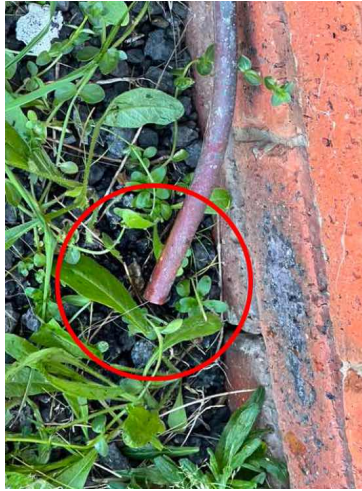
Hot water unit overflow not connected to drain. This provides conducive conditions for termite infestation.

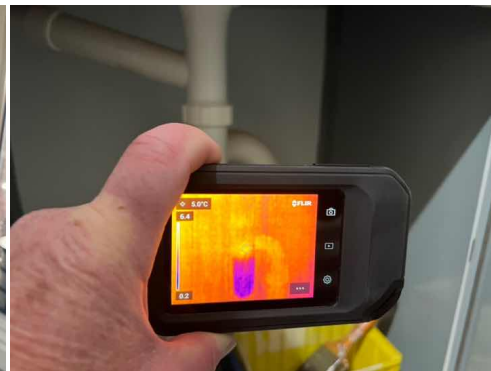
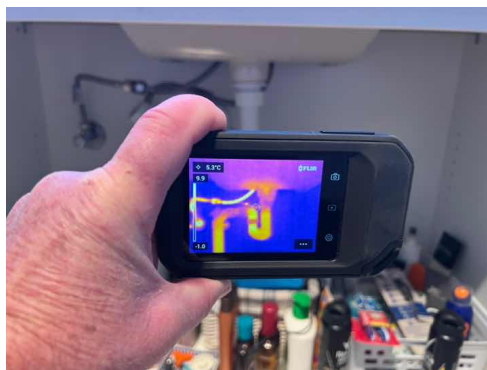
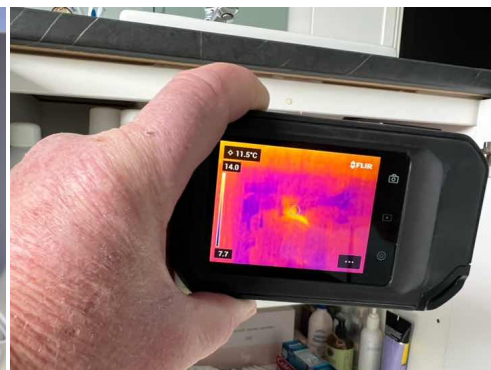
An infrared thermal imager was utilised during the inspection. No thermal anomalies were detected during this inspection, however various factors must be taken into effect which may hamper or impede the reading obtainable by the imager. These factors include obstructions, ambient temperature, wall material and thickness etc. If any surface is restricted visually or otherwise, a proper thermal reading is not possible and is not within the scope of this inspection. Any findings or otherwise is reported on at the time of the inspection only.
